# Memorandum

**Subject:** Honda briefing at ODI, September 4, 2003

Honda requested the September 4<sup>th</sup> meeting to discuss lower crossmember failures on certain 2002/2003 model year GL1800's. This issue was (is) the subject of the National Highway Traffic Safety Administration (NHTSA) Office of Defect Investigations (ODI) Preliminary Evaluation (PE) 03-039. We opened this investigation after becoming aware of crossmember separations and resulting rear suspension collapse involving these motorcycles.

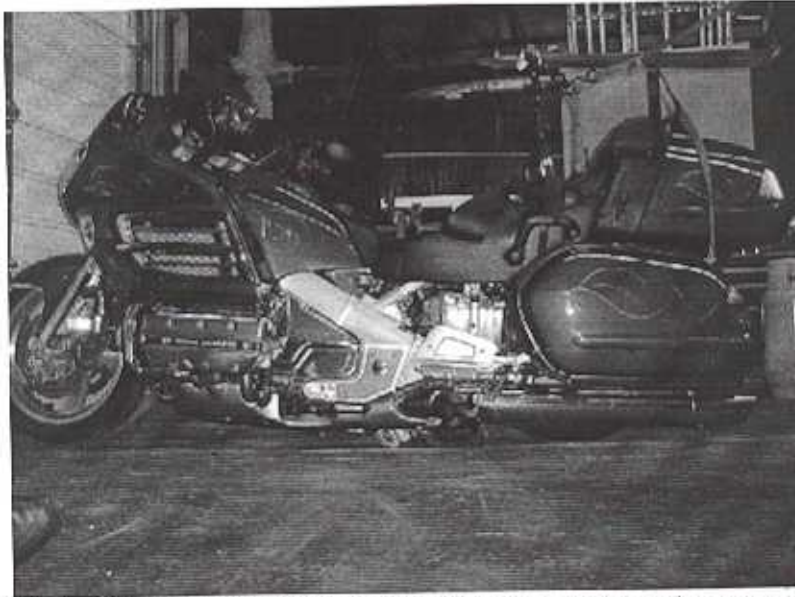
Photo 1 – 2002 GL1800 (built 6-02) w/1600 miles – Separated crossmember

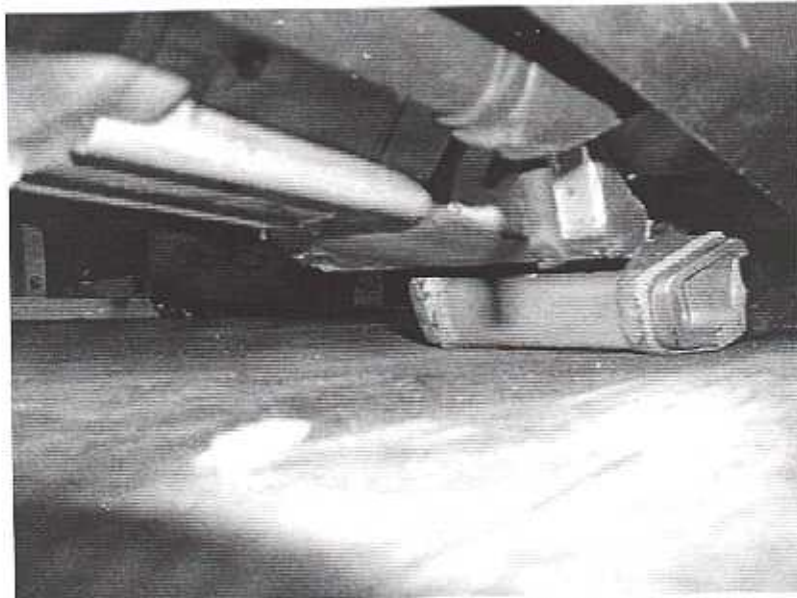
Photo 2 – Separated crossmember dragging on ground

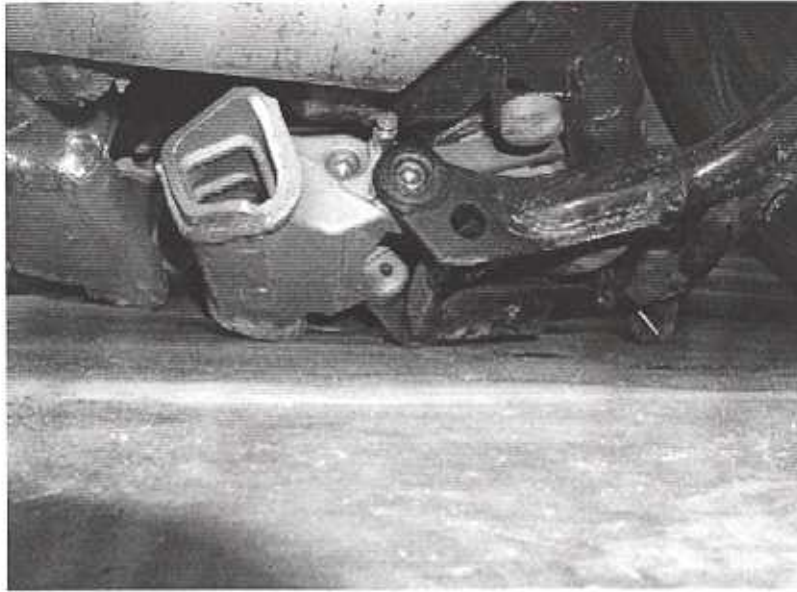
Photo 3 – Separated crossmember and centerstand dragging on ground

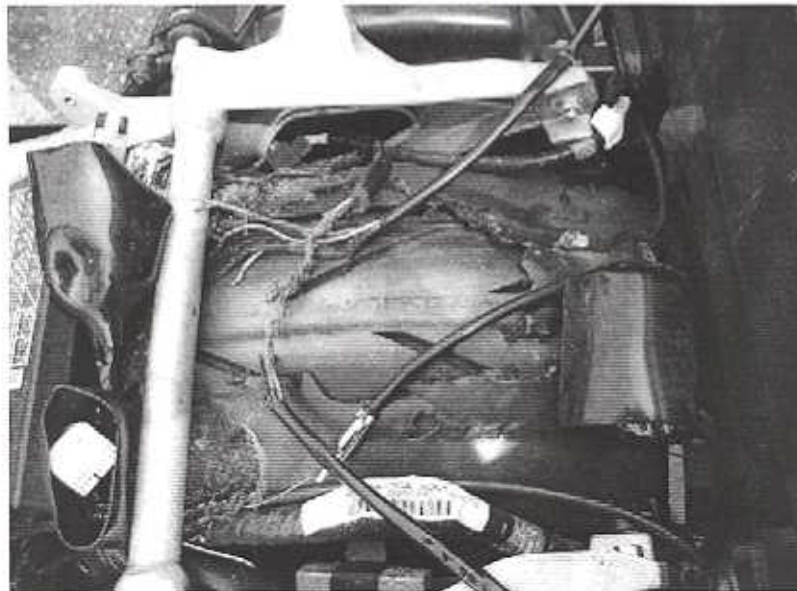
Photo 4 – Inner fender and speaker wires damaged due to tire contact (seat removed)

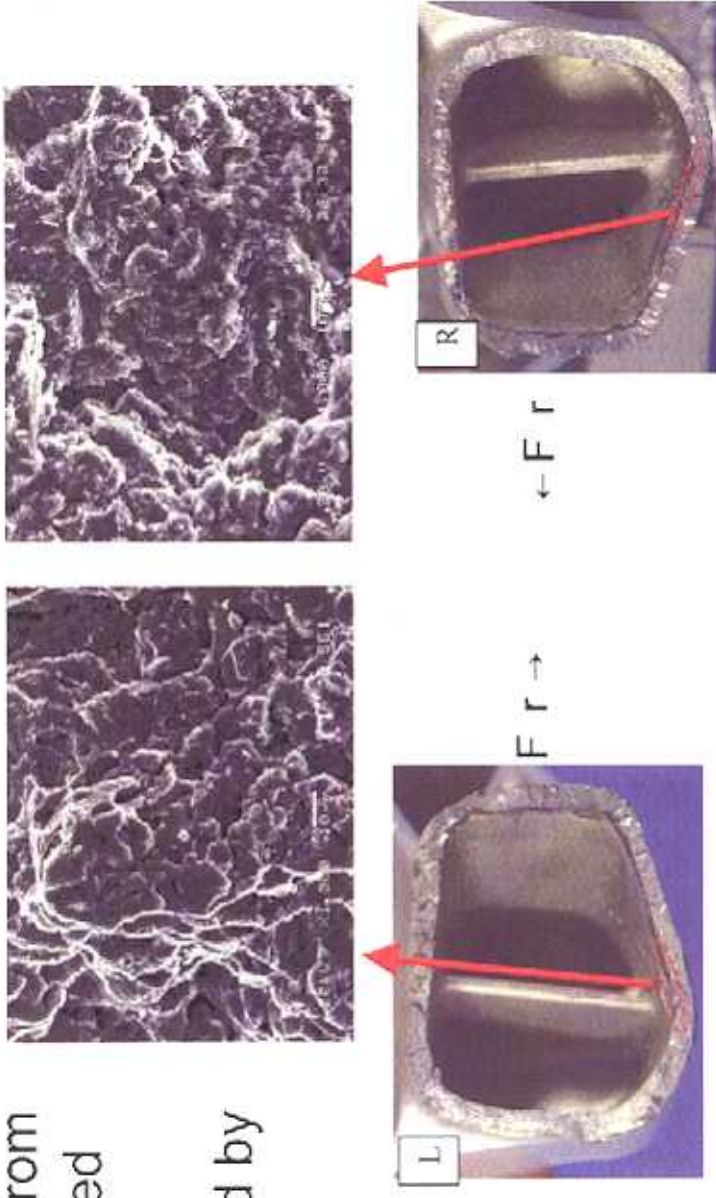
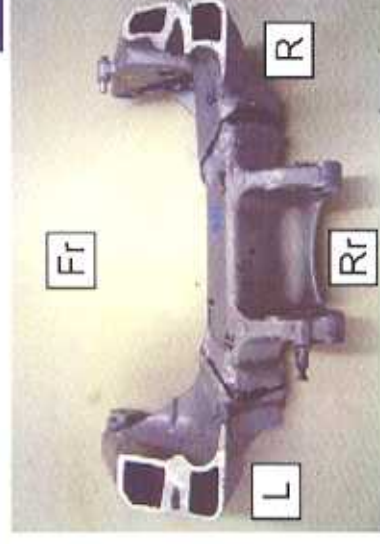
# 1. Confirmation of actual parts –①

## Analysis of **broken** surface

- 1 . Breakage originated from the inside of the welded area.
- 2 . Breakage was caused by a one-time impact.  
(Not fatigue broken)

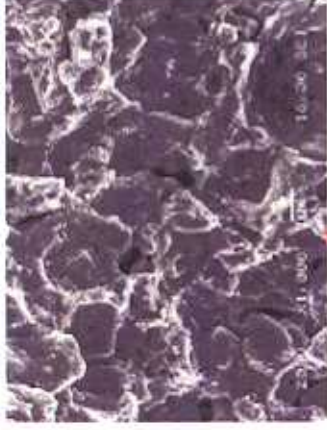
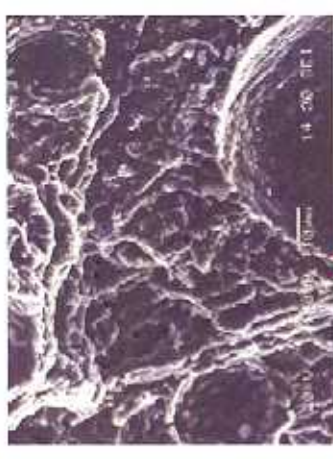
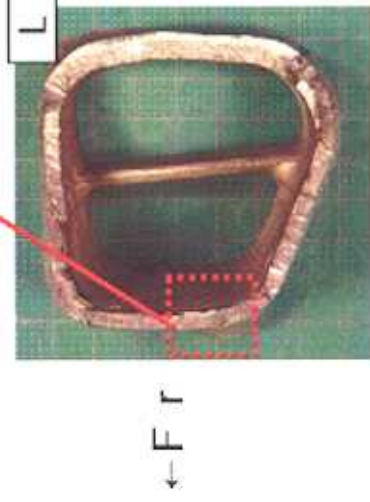
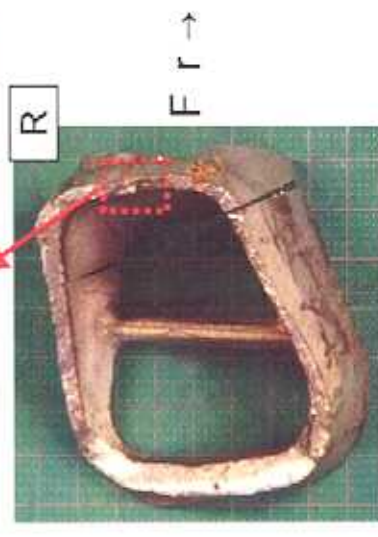
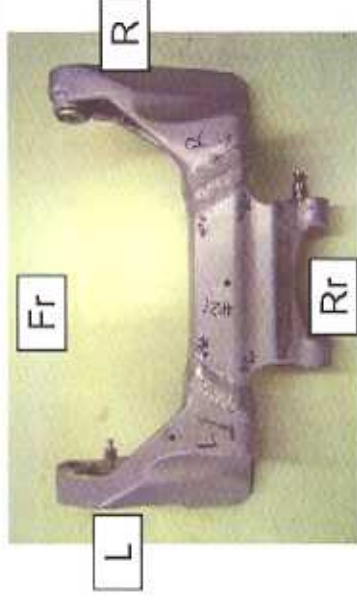
# 1. Confirmation of actual parts –②

## Analysis of Crack surface

1. Breakage originated from the inside of the welded area.
2. Breakage was caused by a one-time impact.  
(Not fatigue crack)
