# Memorandum

**Subject:** Honda briefing at ODI, September 4, 2003

Honda requested the September 4<sup>th</sup> meeting to discuss lower crossmember failures on certain 2002/2003 model year GL1800's. This issue was (is) the subject of the National Highway Traffic Safety Administration (NHTSA) Office of Defect Investigations (ODI) Preliminary Evaluation (PE) 03-039. We opened this investigation after becoming aware of crossmember separations and resulting rear suspension collapse involving these motorcycles.

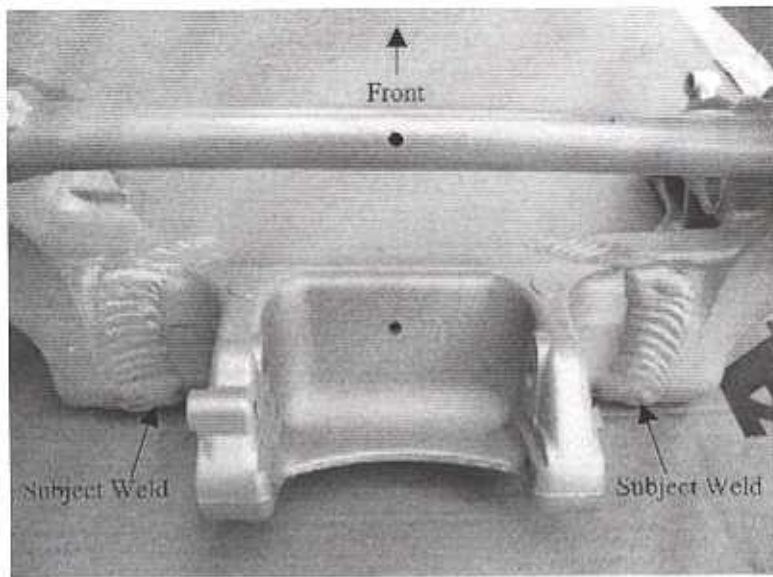
Photo 5 – Subject crossmember

ODI also inspected the replacement frame, built in May 2003, intended for the motorcycle described in Section 3.0. This afforded us the unique opportunity to fully view the subject crossmember and its welds. The frame shown was never installed as Honda elected to replace the damaged machine with a new 2003 model.

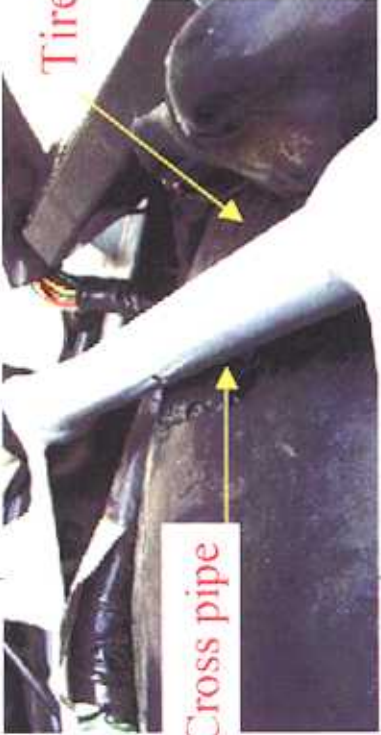
| | potential problem | Phenomenon | Result |
|---|---|---|---|
| ① | Fall<br>A puncture caused by interference between the rear tire and fender. | <p>The fender is made of plastic and no sharp parts are in contact with rear tire. The cross pipe is cylindrical.</p> | No puncture |

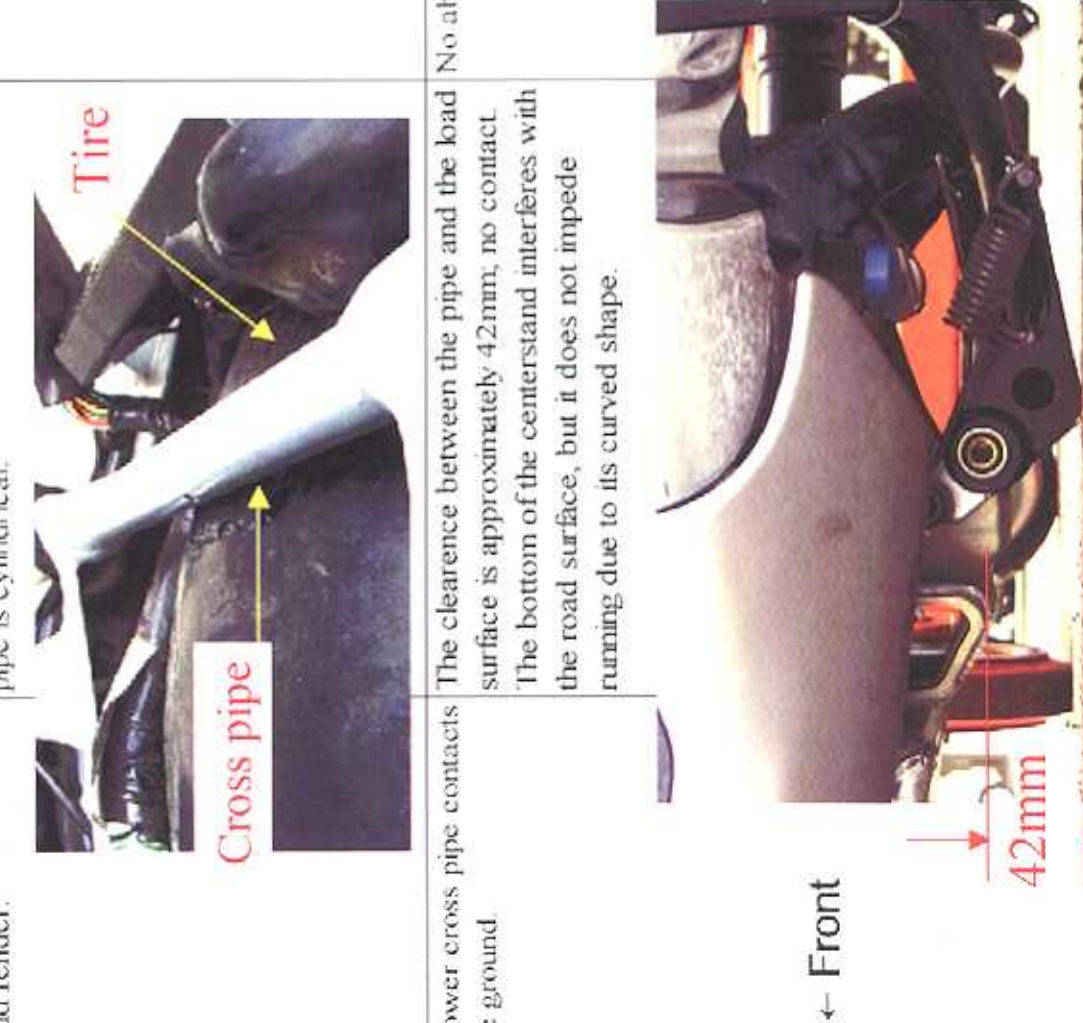
| | potential problem | Phenomenon | Result |
|---|---|---|---|
| | The lower cross pipe contacts on the ground. | <p>The clearance between the pipe and the load surface is approximately 42mm, no contact. The bottom of the centerstand interferes with the road surface, but it does not impede running due to its curved shape.</p> | No abrupt movement |

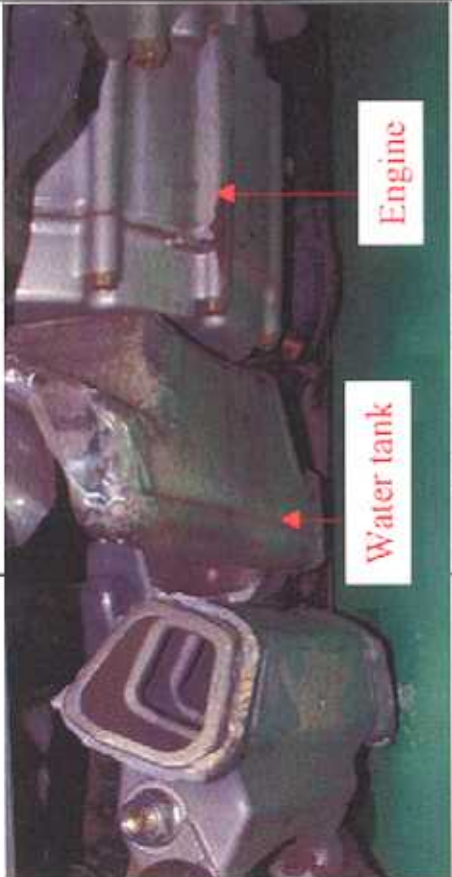
| | Potential problem | Phenomenon | Result |
|---|---|---|---|
| ② | fall<br>Slip by leakage of oil or coolant | <p>The cross pipe hangs down out of place, but it does not come off nor cause any damage to the engine case and water tank.</p> | No damage on the engine and cooling system. |

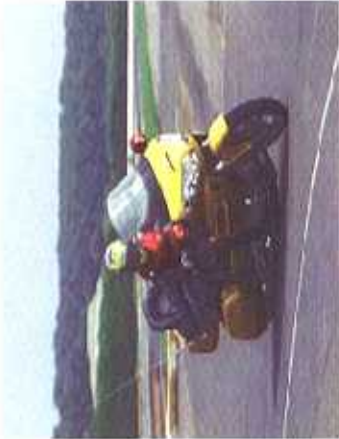
| | Potential problem | Phenomenon | Result |
|---|---|---|---|
| | Bank angle decrease<br><br>From the video of breakage test | <p>dynamic bank angle is 19°<br/>Normal running and turning are still possible</p> | Bank angle is slightly reduced. |

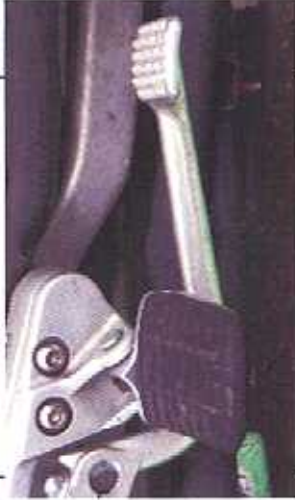
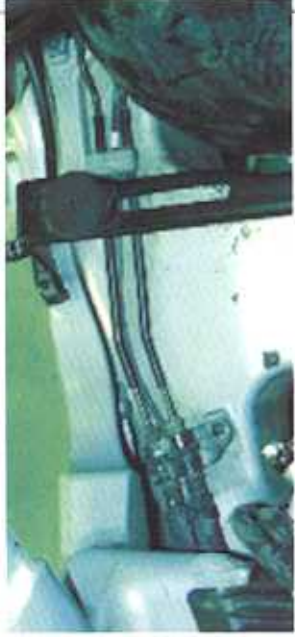
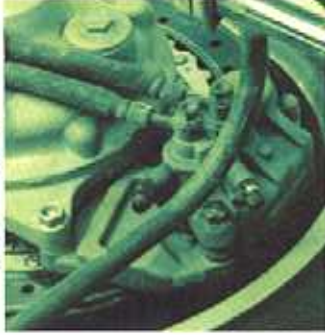
| | Potential problem | Phenomenon | Result |
|---|---|---|---|
| ②<br>Loss of control | Failure of drive train, transmission or braking system.<br><br>Pedal area<br> | No interference to related components<br><br>Brake pipe<br> | No damage to any related components<br><br>Caliper area<br> |

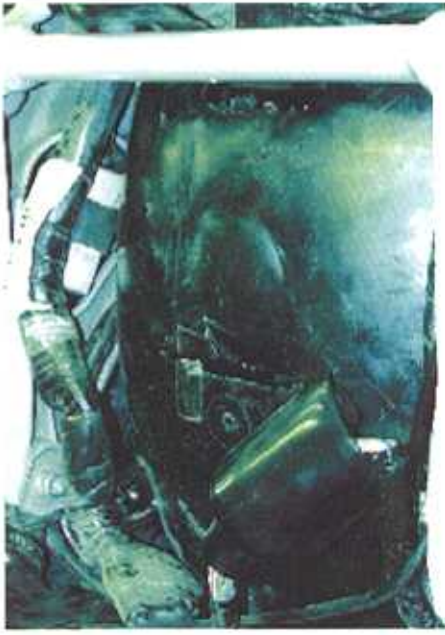
| | Potential problem | Phenomenon | Result |
|---|---|---|---|
| ③<br>Fire | Electrical harness, open circuit and short circuit | No harness open circuit or short circuit after separation and prior to stopping<br> | Electrical system is normal |

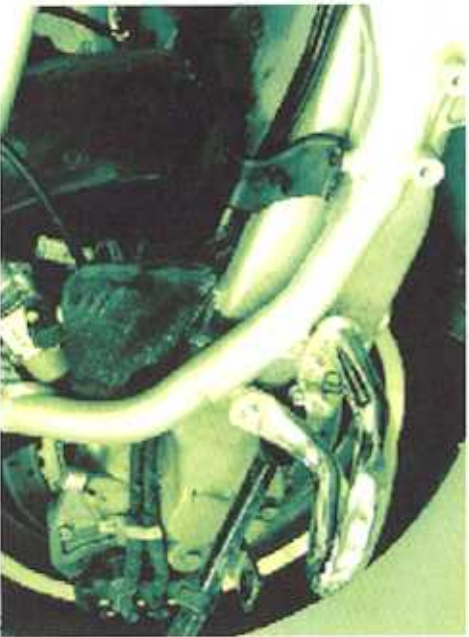
| | Potential problem | Phenomenon | Result |
|---|---|---|---|
| | In case any broken parts are caught in the rear wheel they may cause a lock.. | | No rear wheel lock occurs. |

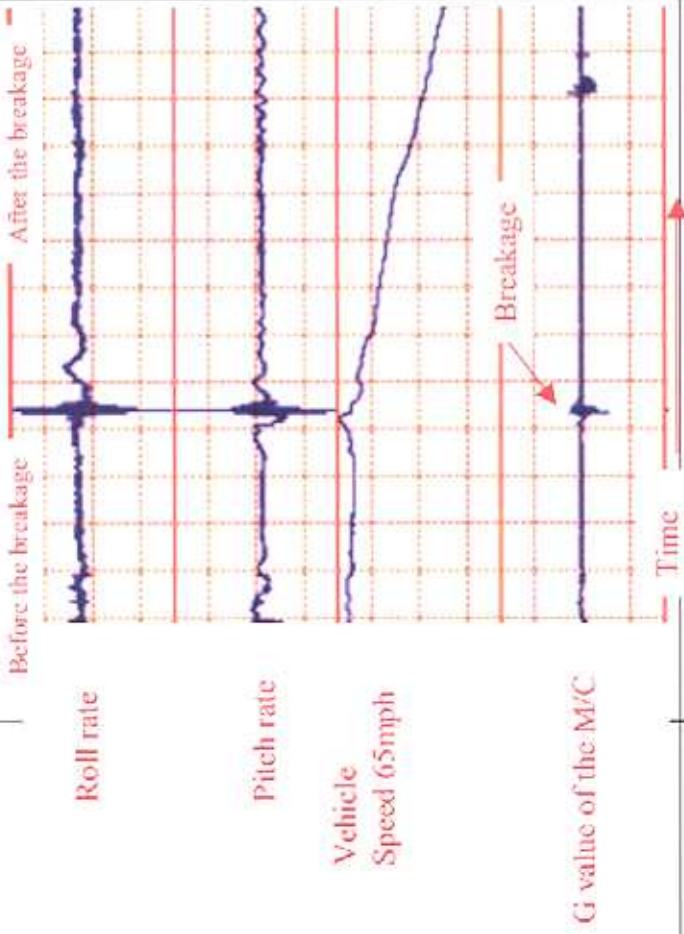
| | Potential problem | Phenomenon | Result |
|---|---|---|---|
| ⑧ Injury of the rider | Possibility of the rider being thrown from the bike by the shock of the cross pipe failure. | <p>Very slight shock at the moment of failure.<br/>No significant difference in pitch rate and roll rate of body before and after the failure.</p> <p>Roll rate</p> <p>Pitch rate</p> <p>Vehicle Speed 65mph</p> <p>G value of the M/C</p> <p>Before the breakage After the breakage</p> <p>Time</p> | Rider remains on motorcycle. |

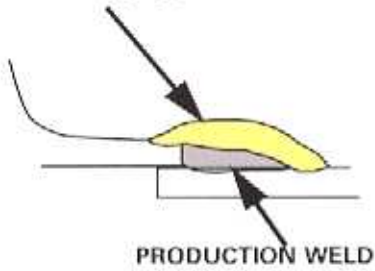
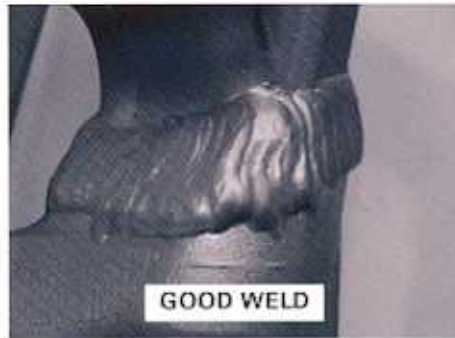
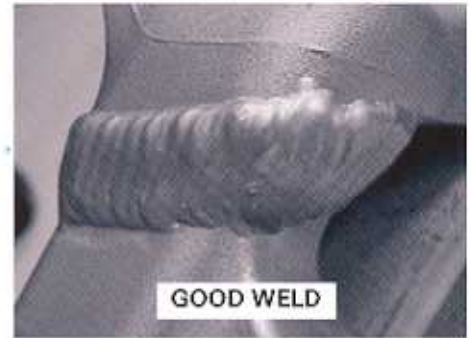
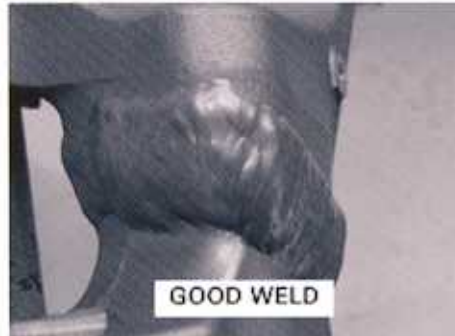
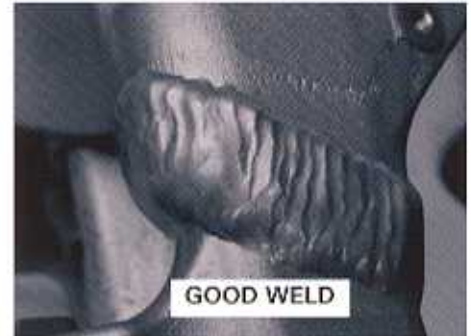
This section shows you how to accurately identify **GOOD** TIG welds.

New weld shape is convex,  
overlapping production weld.

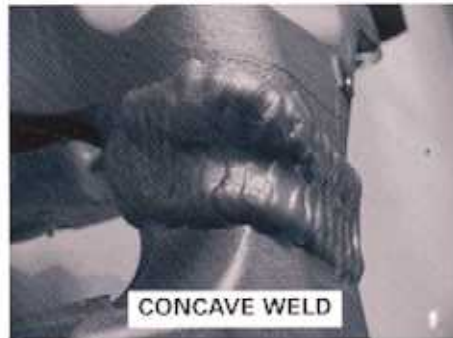
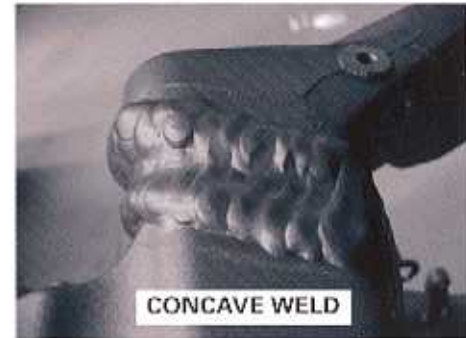
CONCAVE WELD

This section shows you how to accurately identify the following types of **NO GOOD** TIG welds: **Concave Weld**, **Cold Weld**.

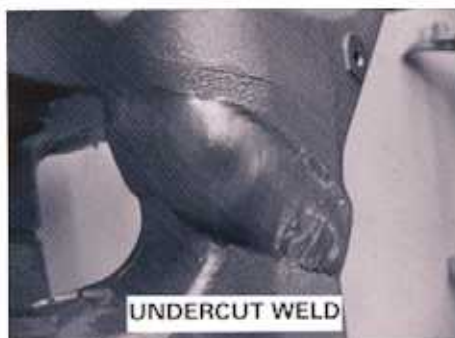
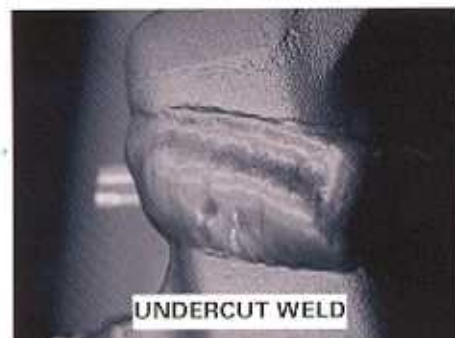
UNDERCUT WELD

This section shows you how to accurately identify the following types of **NO GOOD TIG** welds: **Undercut Weld**, **Dirty Weld**.

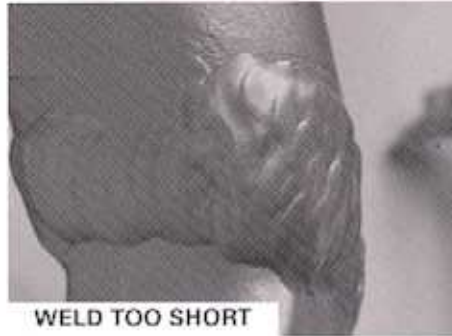
**WELD TOO SHORT**

This section shows you how to accurately identify the following types of **NO GOOD** TIG welds: **Weld Too Short**, **Weld Too Long**.

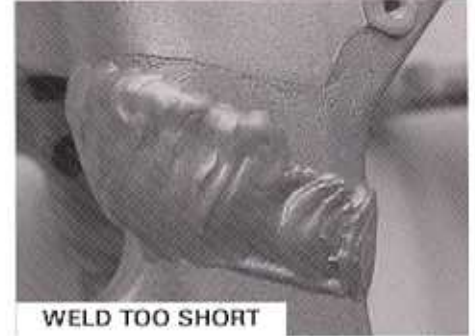
**WELD TOO SHORT****WELD TOO LONG**

If you find any No Good welds, call your DSM or TechLine at (800) 421-1900 for further instructions.

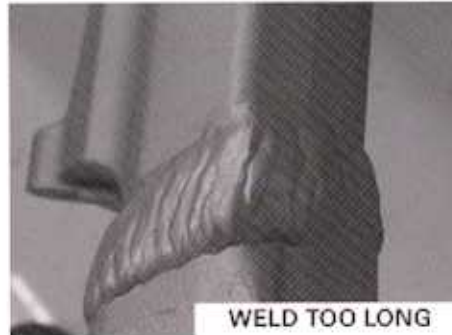
**WELD TOO LONG**

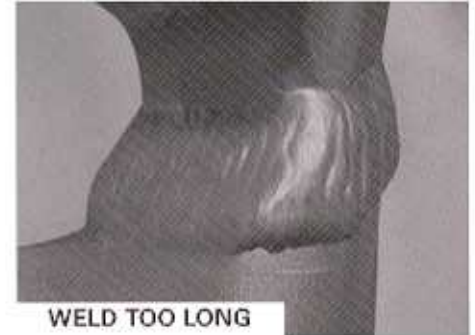
**WELD TOO LONG**

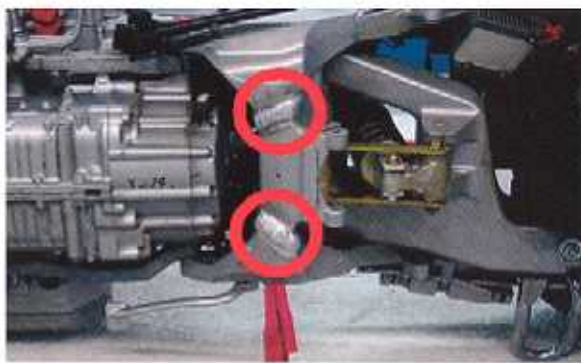
You will be welding at the locations shown above.
